MEC SITE INSPECTION

Genova v. Johnson

D.O.I. - 08/22/2017

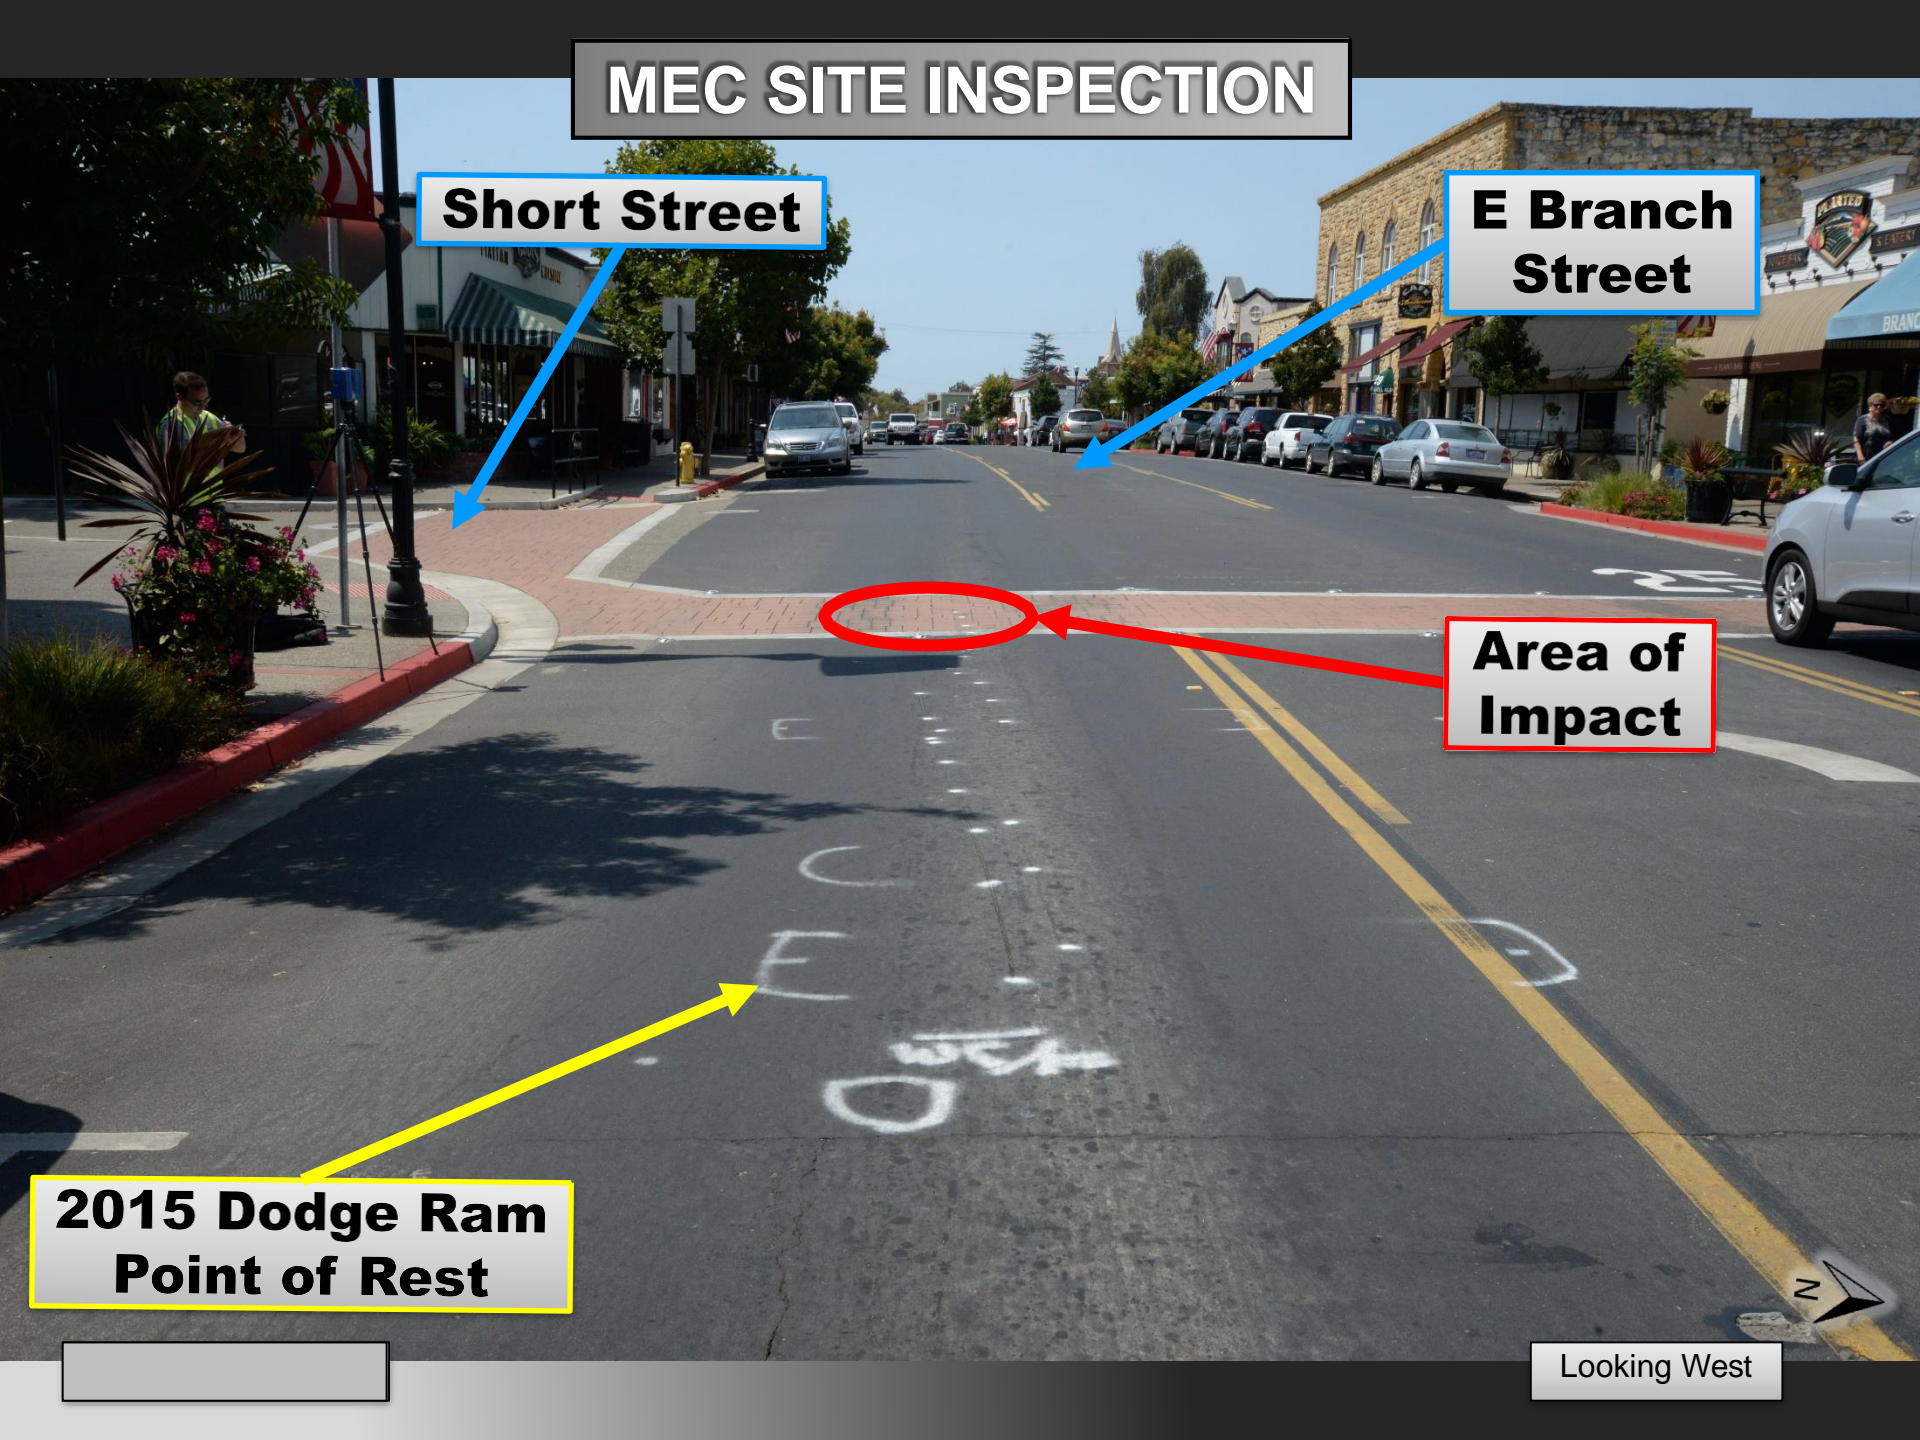
Area of Impact

**2015 Dodge Ram
Point of Rest**

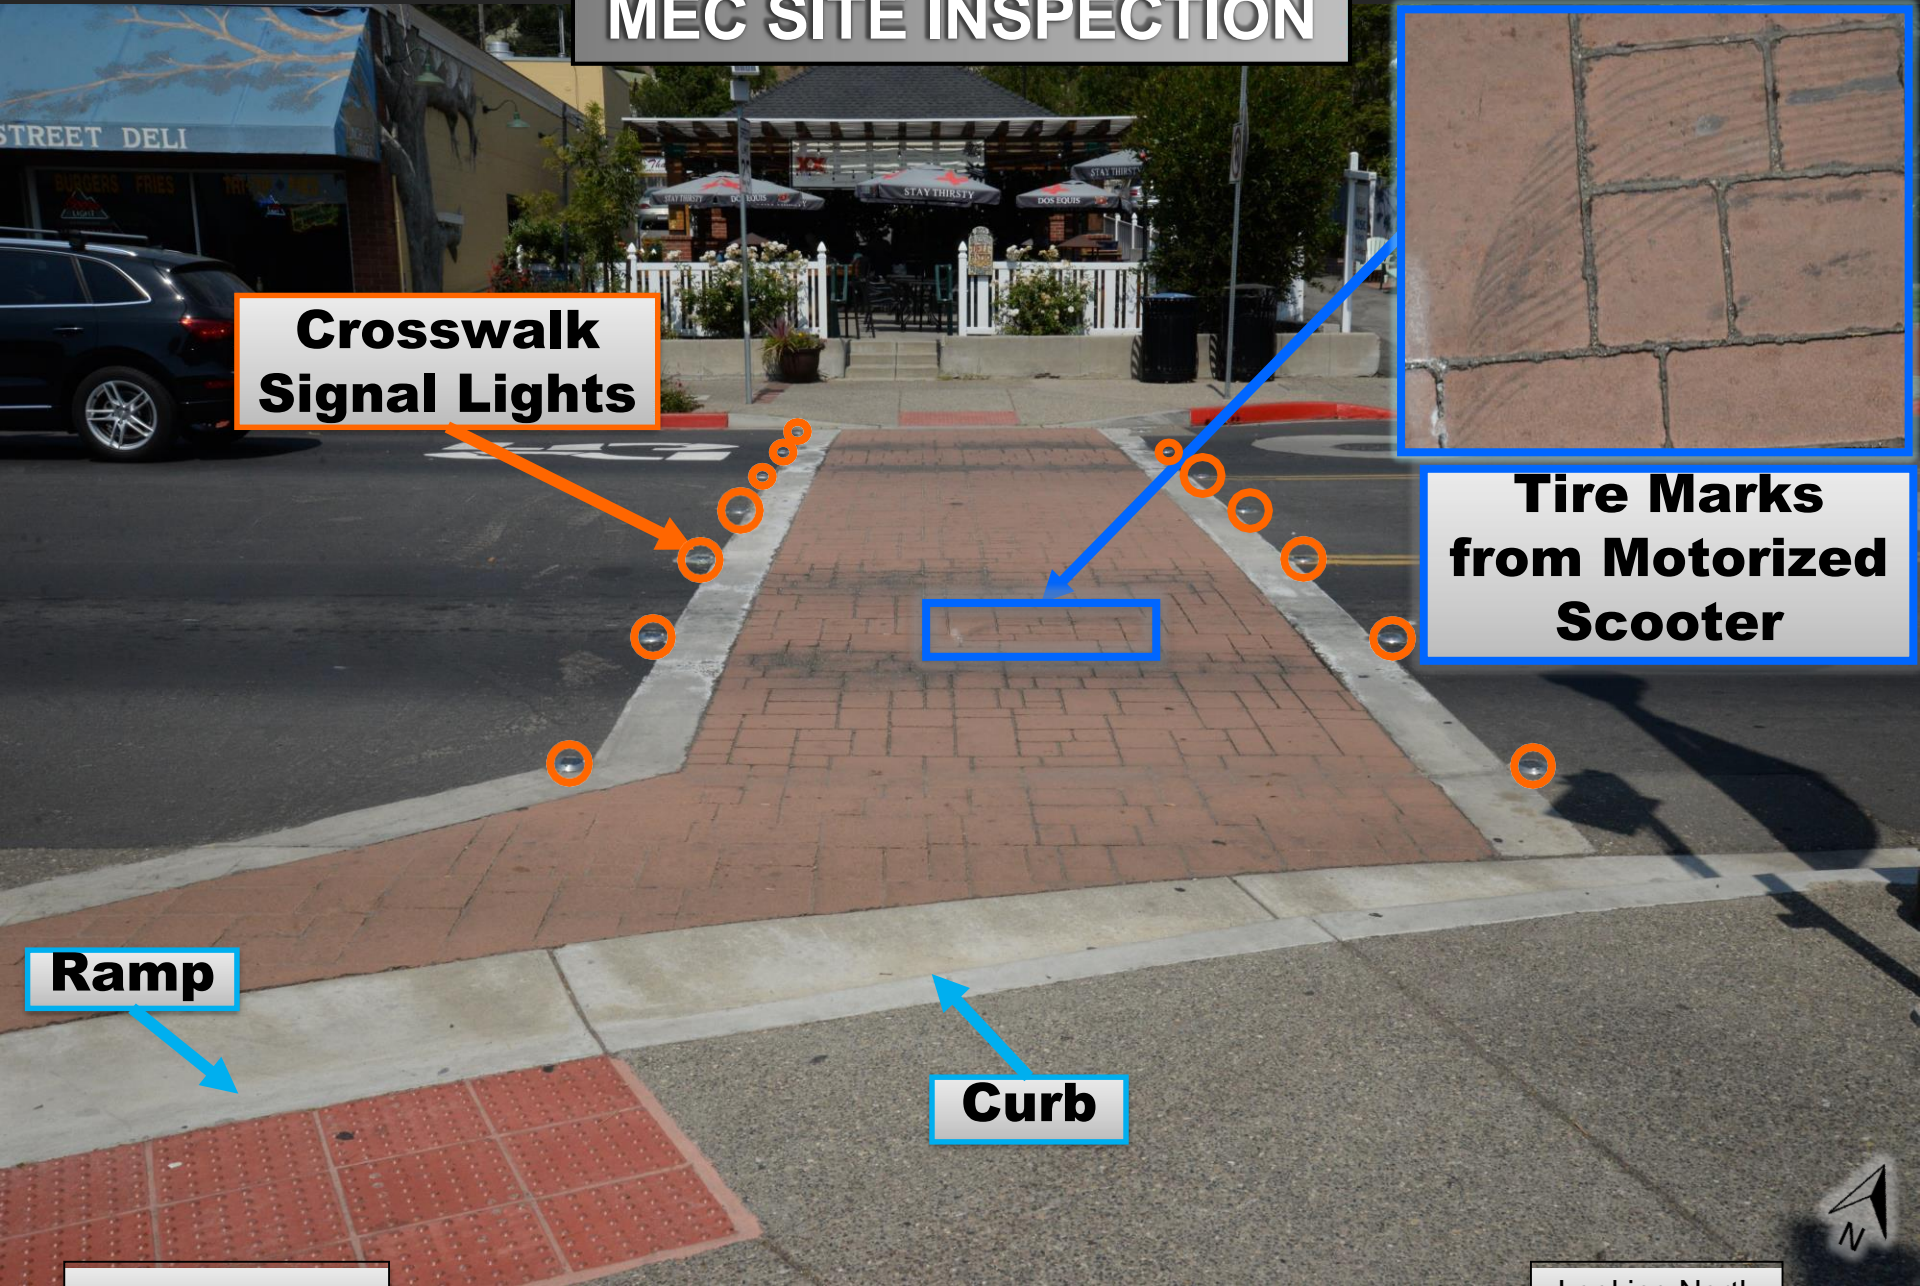
**Crosswalk
Signal Lights**

**Tire Marks
from Motorized
Scooter**

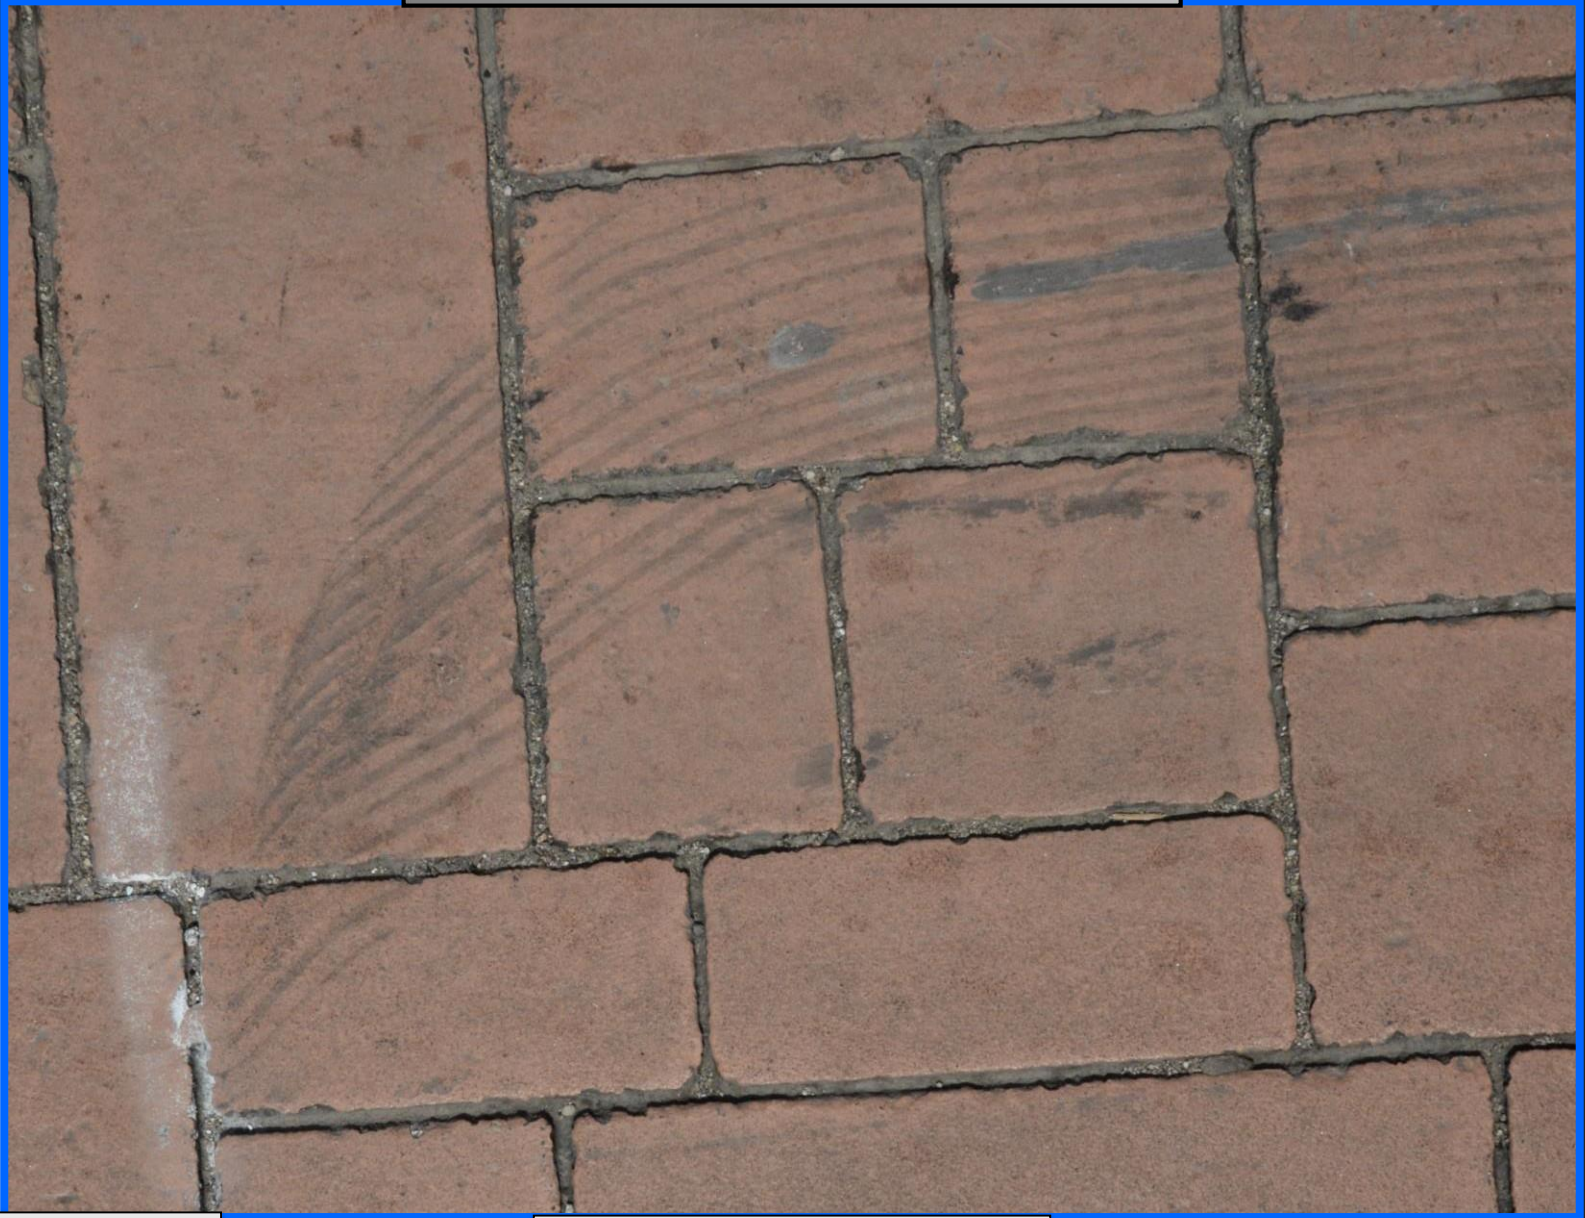
Tire Mark from Motorized Scooter

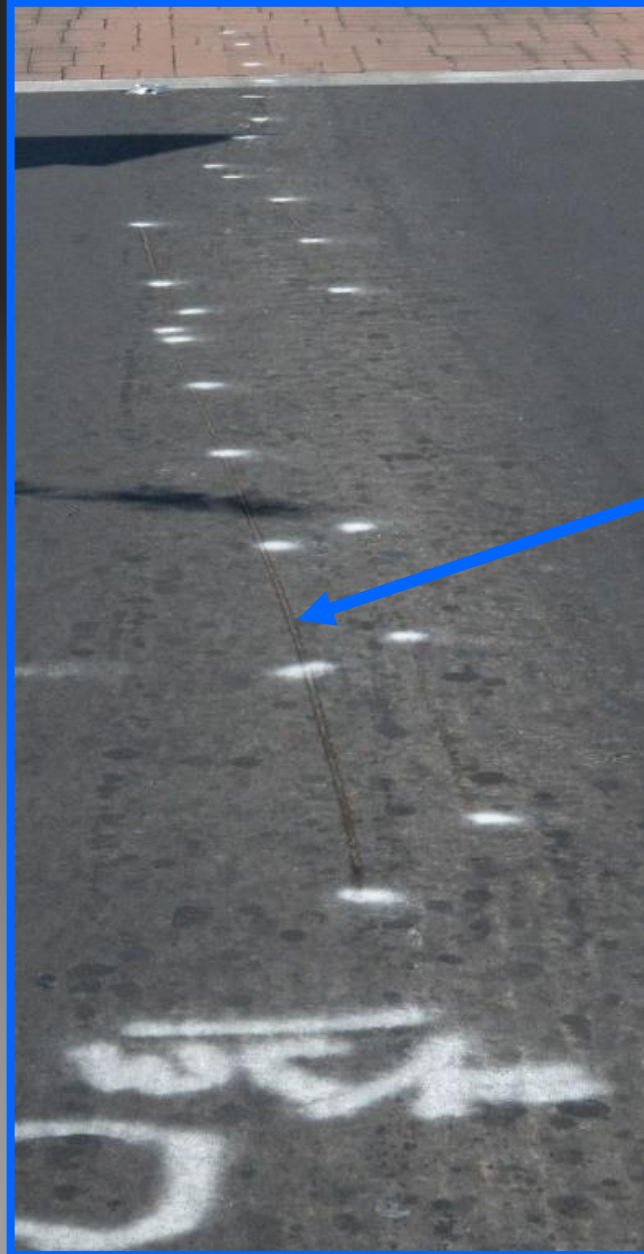
**Gouge Marks
from Motorized
Scooter**

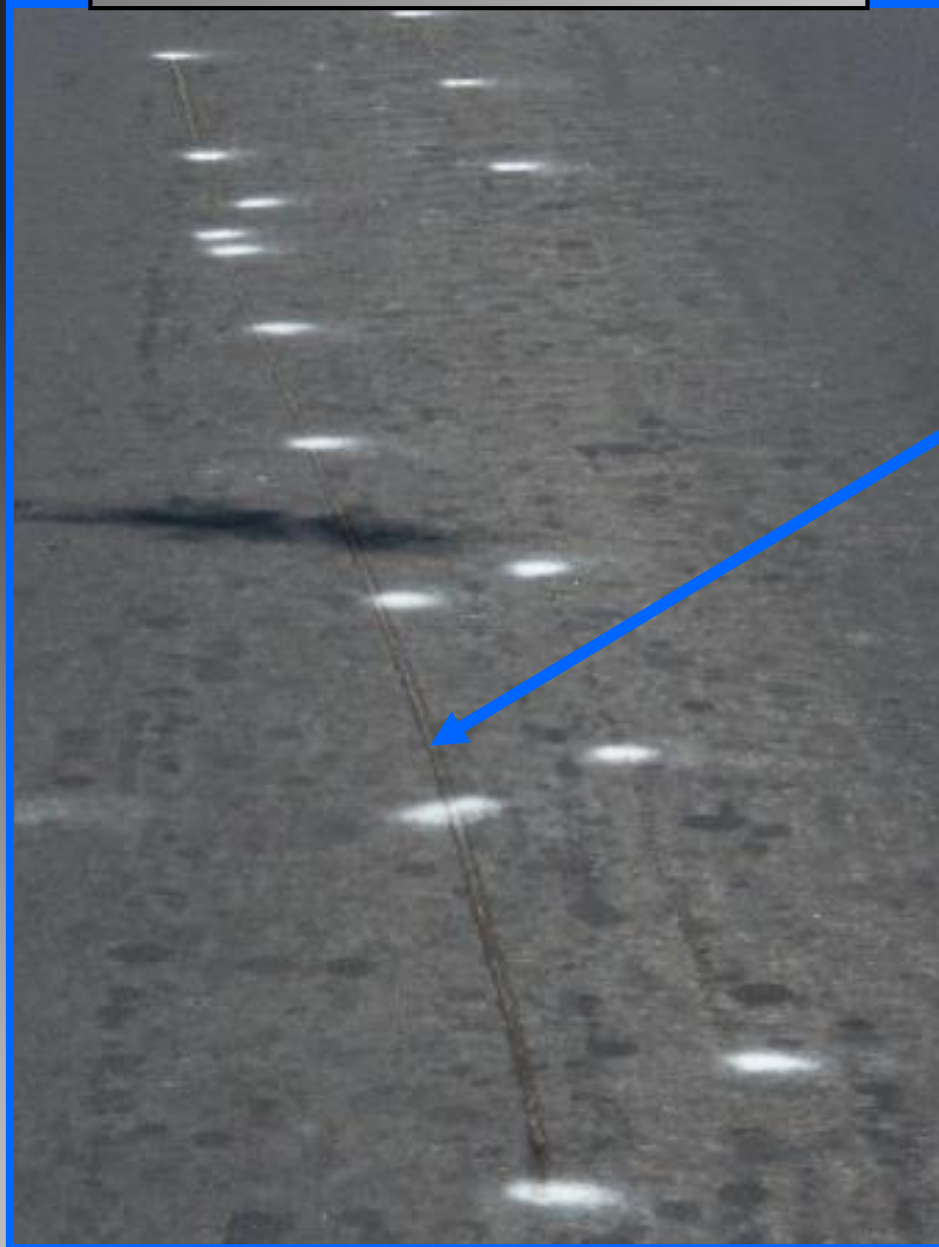
**Gouge
Marks
from
Motorized
Scooter**

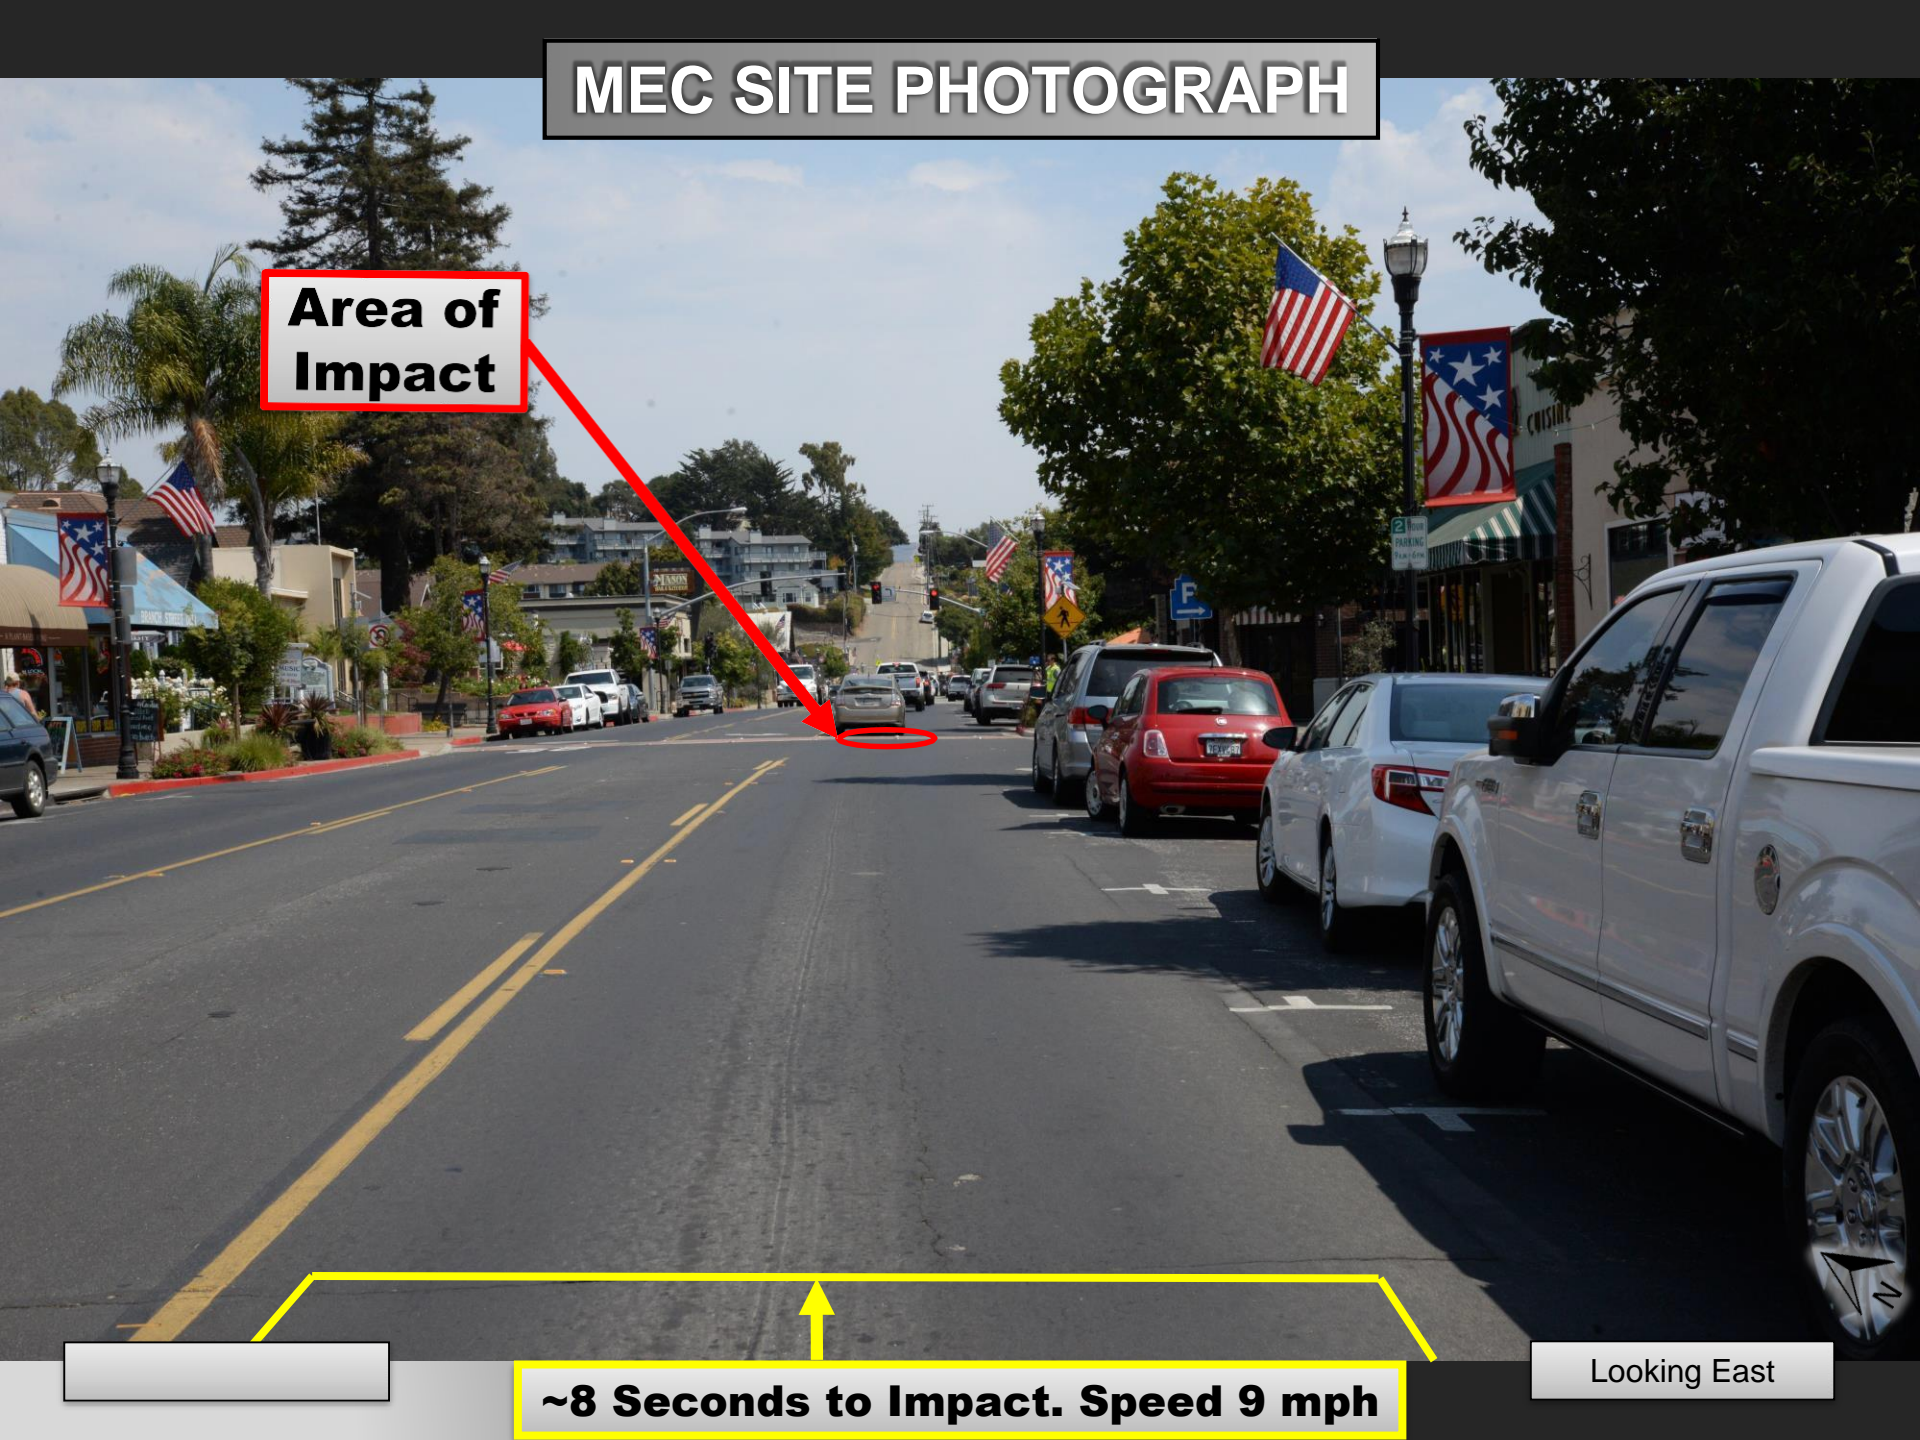
**Area of
Impact**

~8 Seconds to Impact. Speed 9 mph

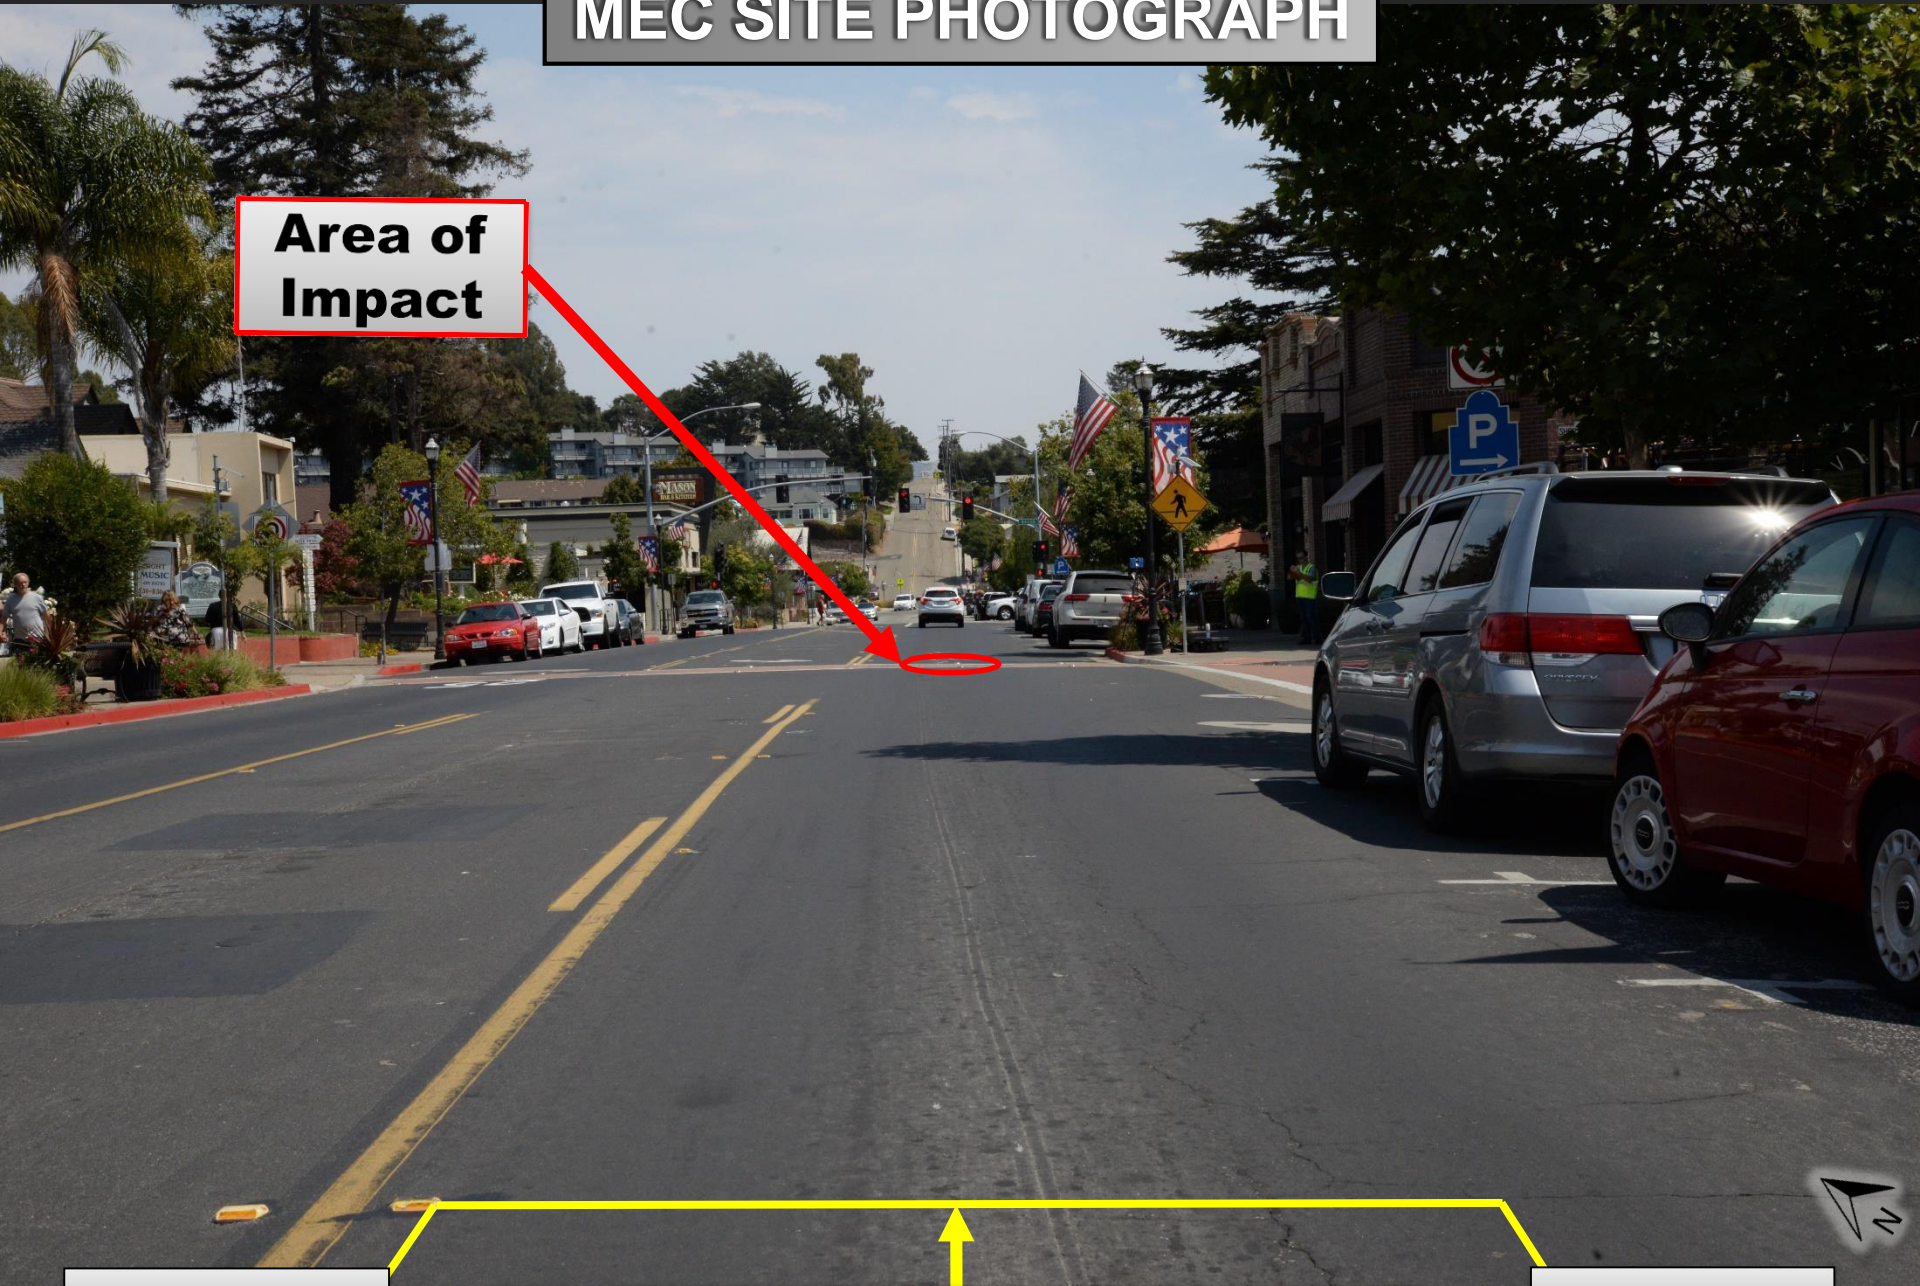
**Area of
Impact**

~5 Seconds to Impact. Speed 15 mph

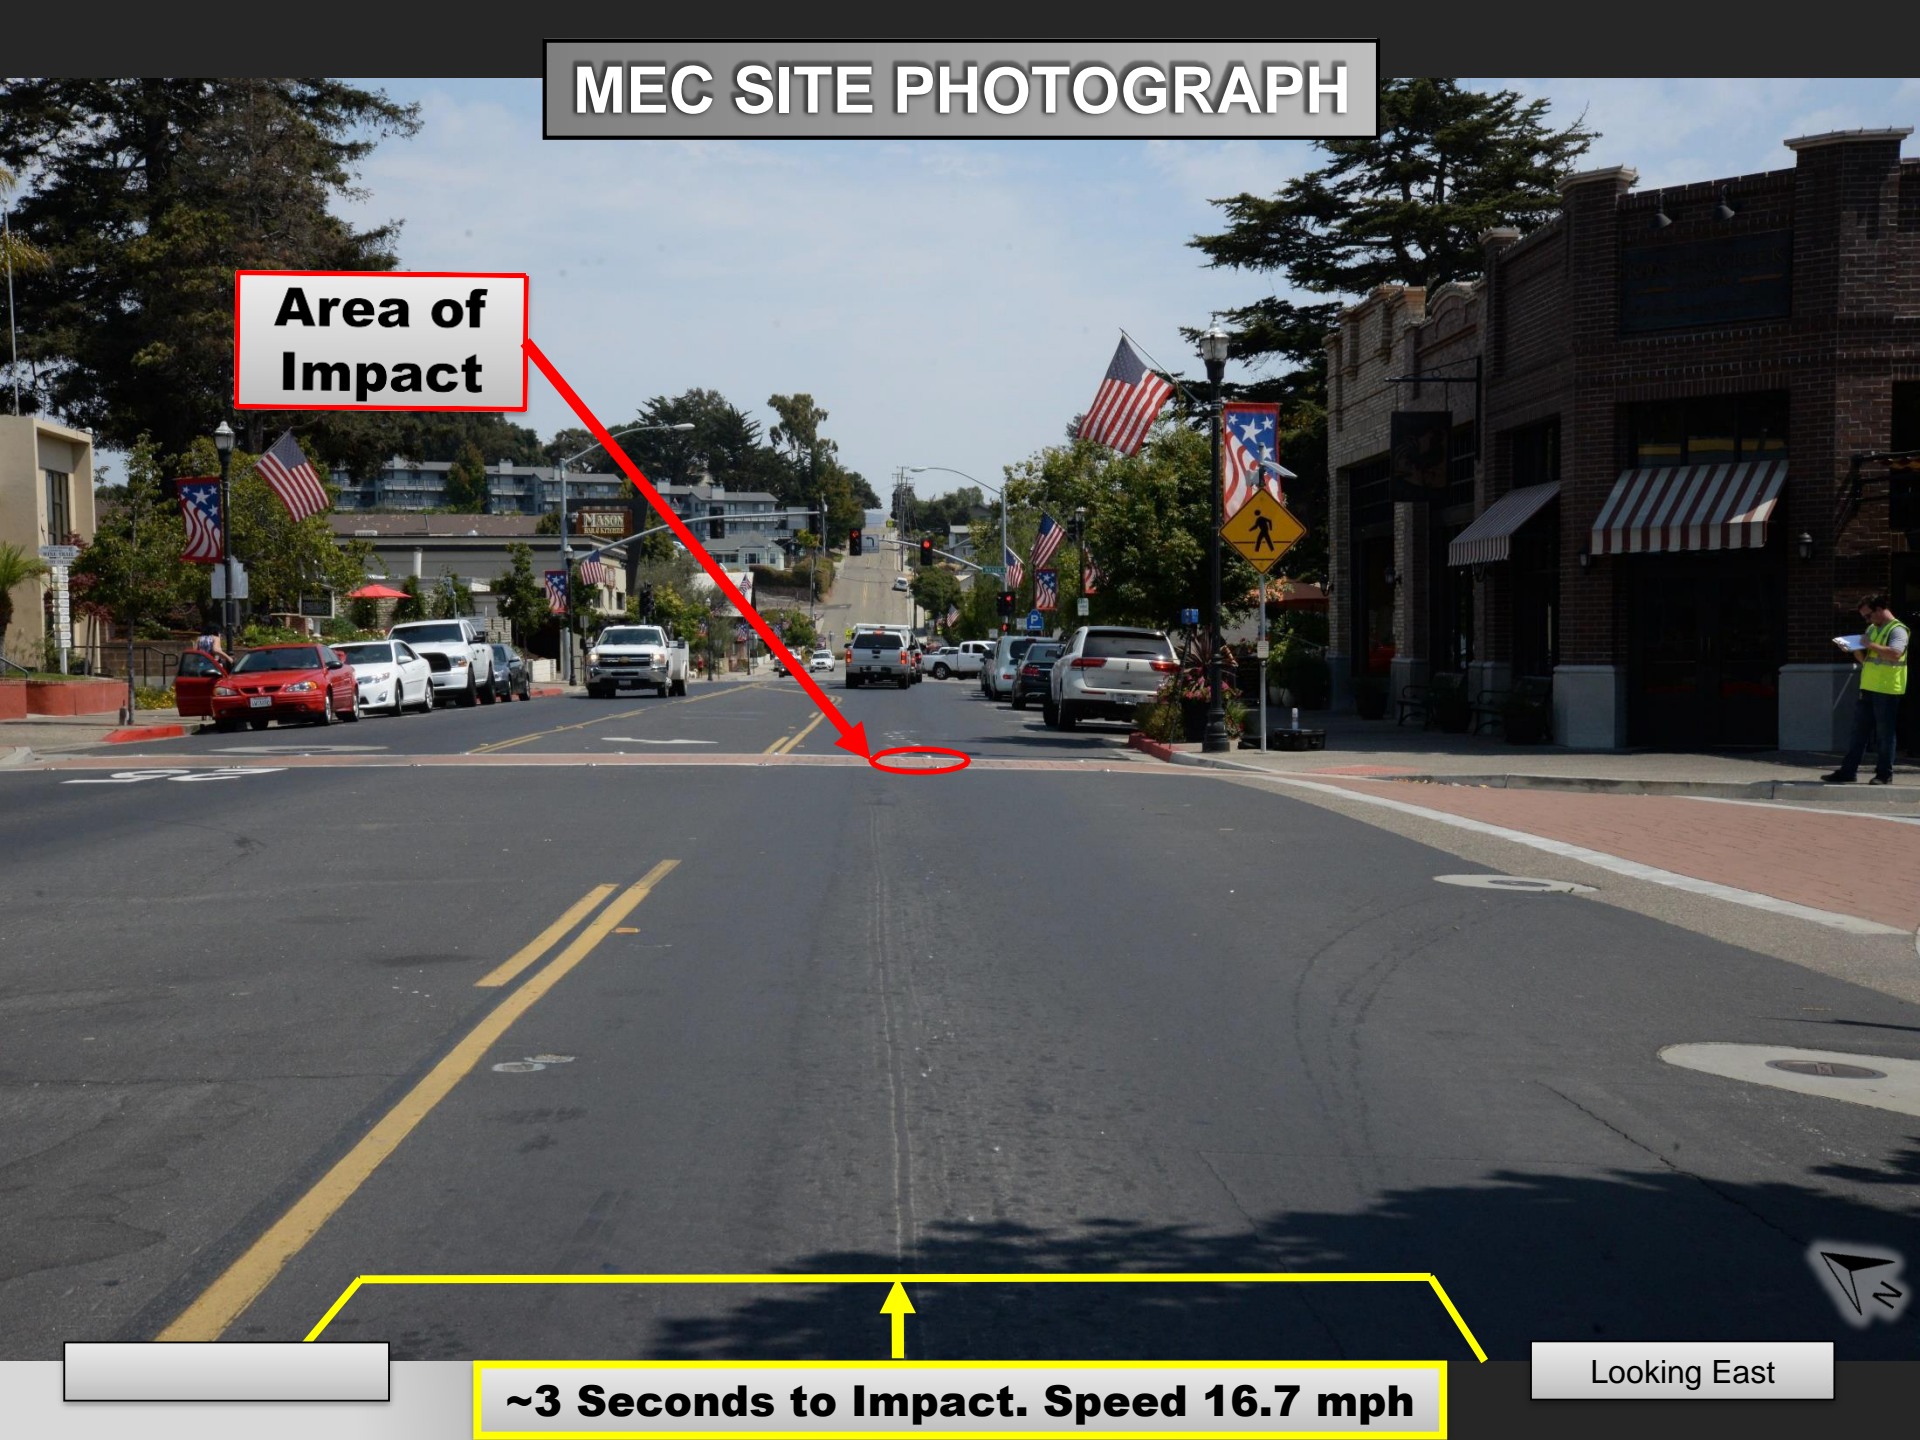
Area of Impact

~3 Seconds to Impact. Speed 16.7 mph

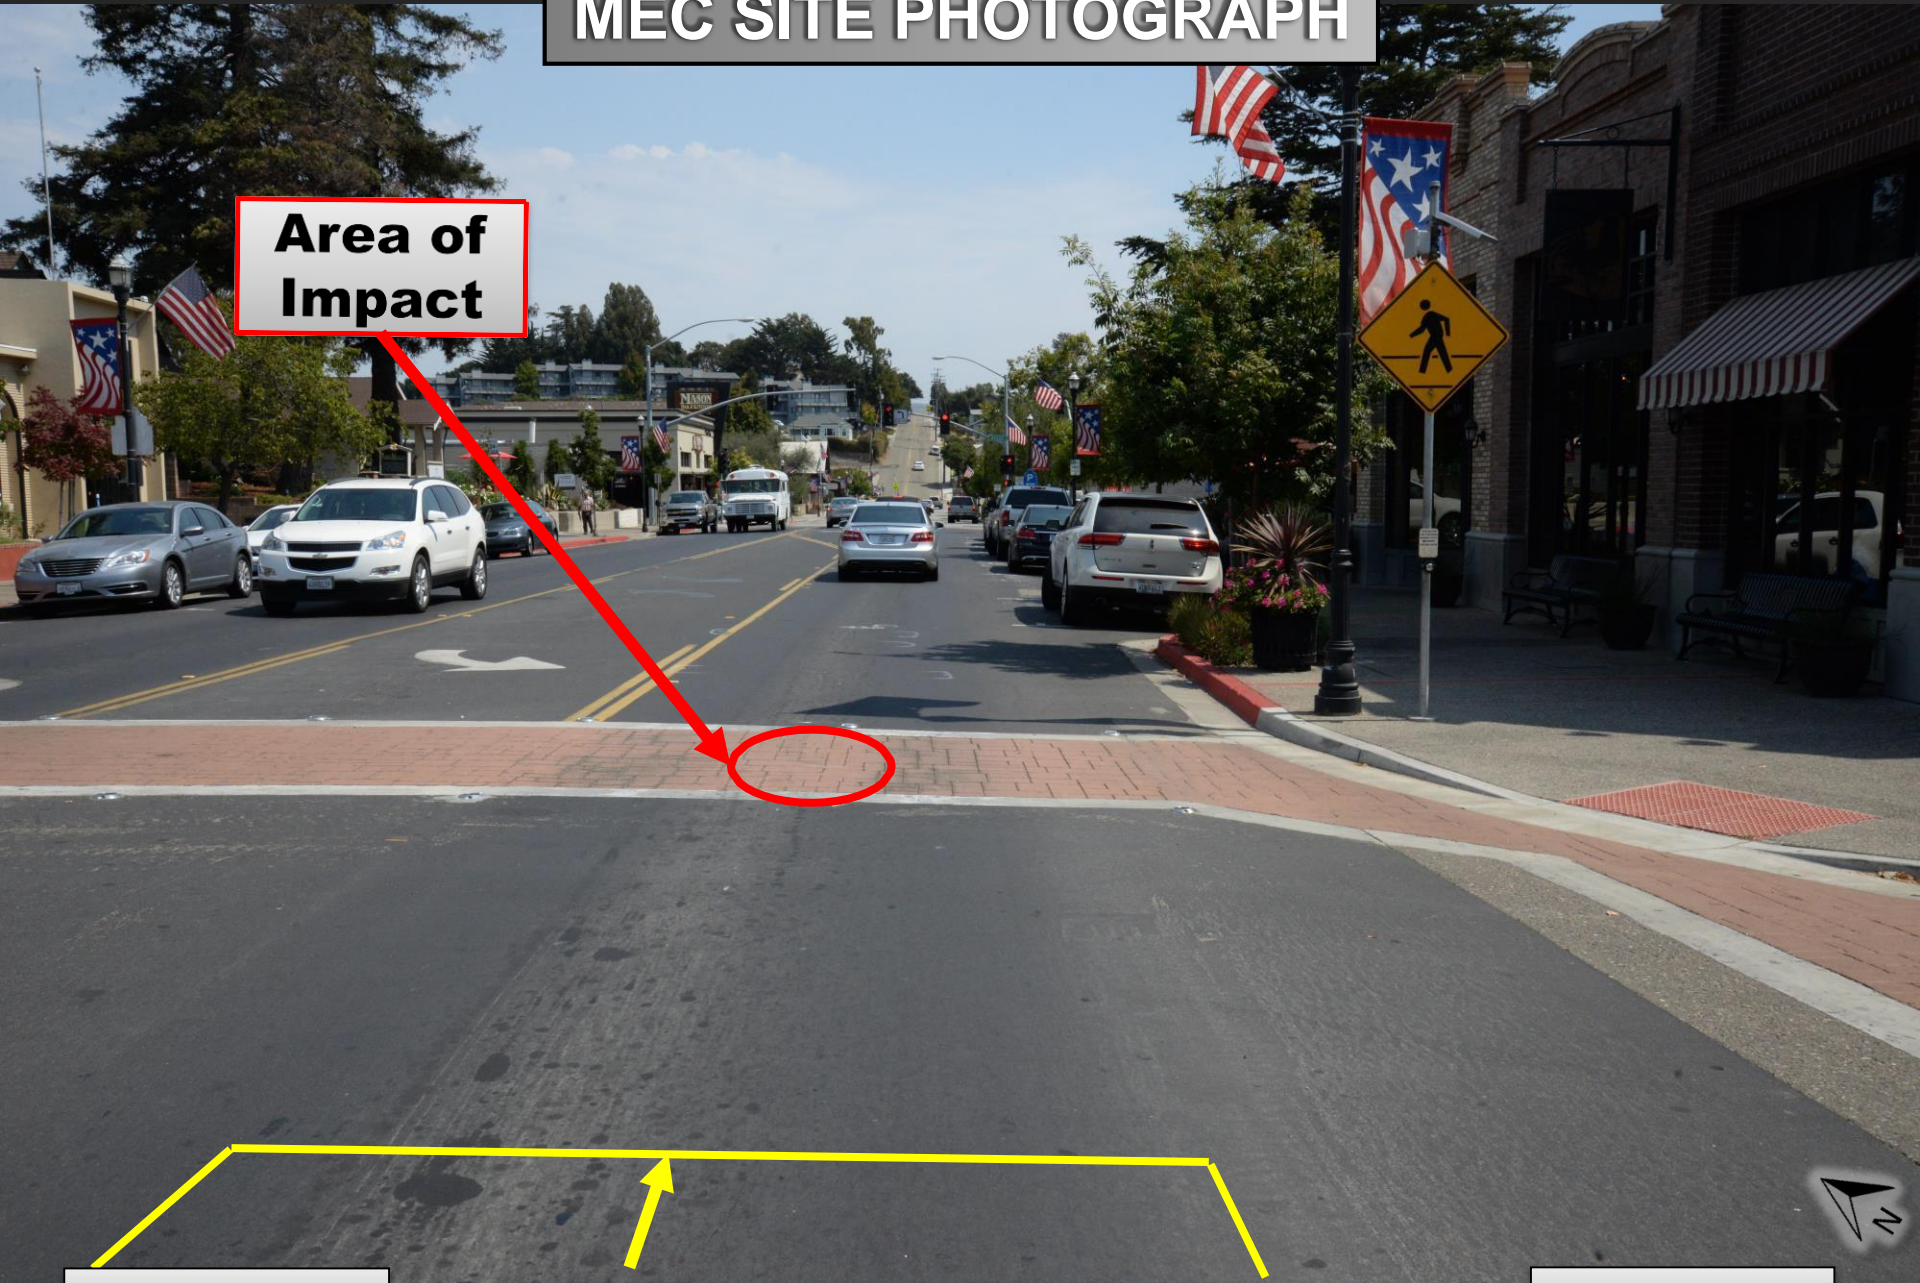
**Area of
Impact**

~2 Seconds to Impact. Speed 17 mph

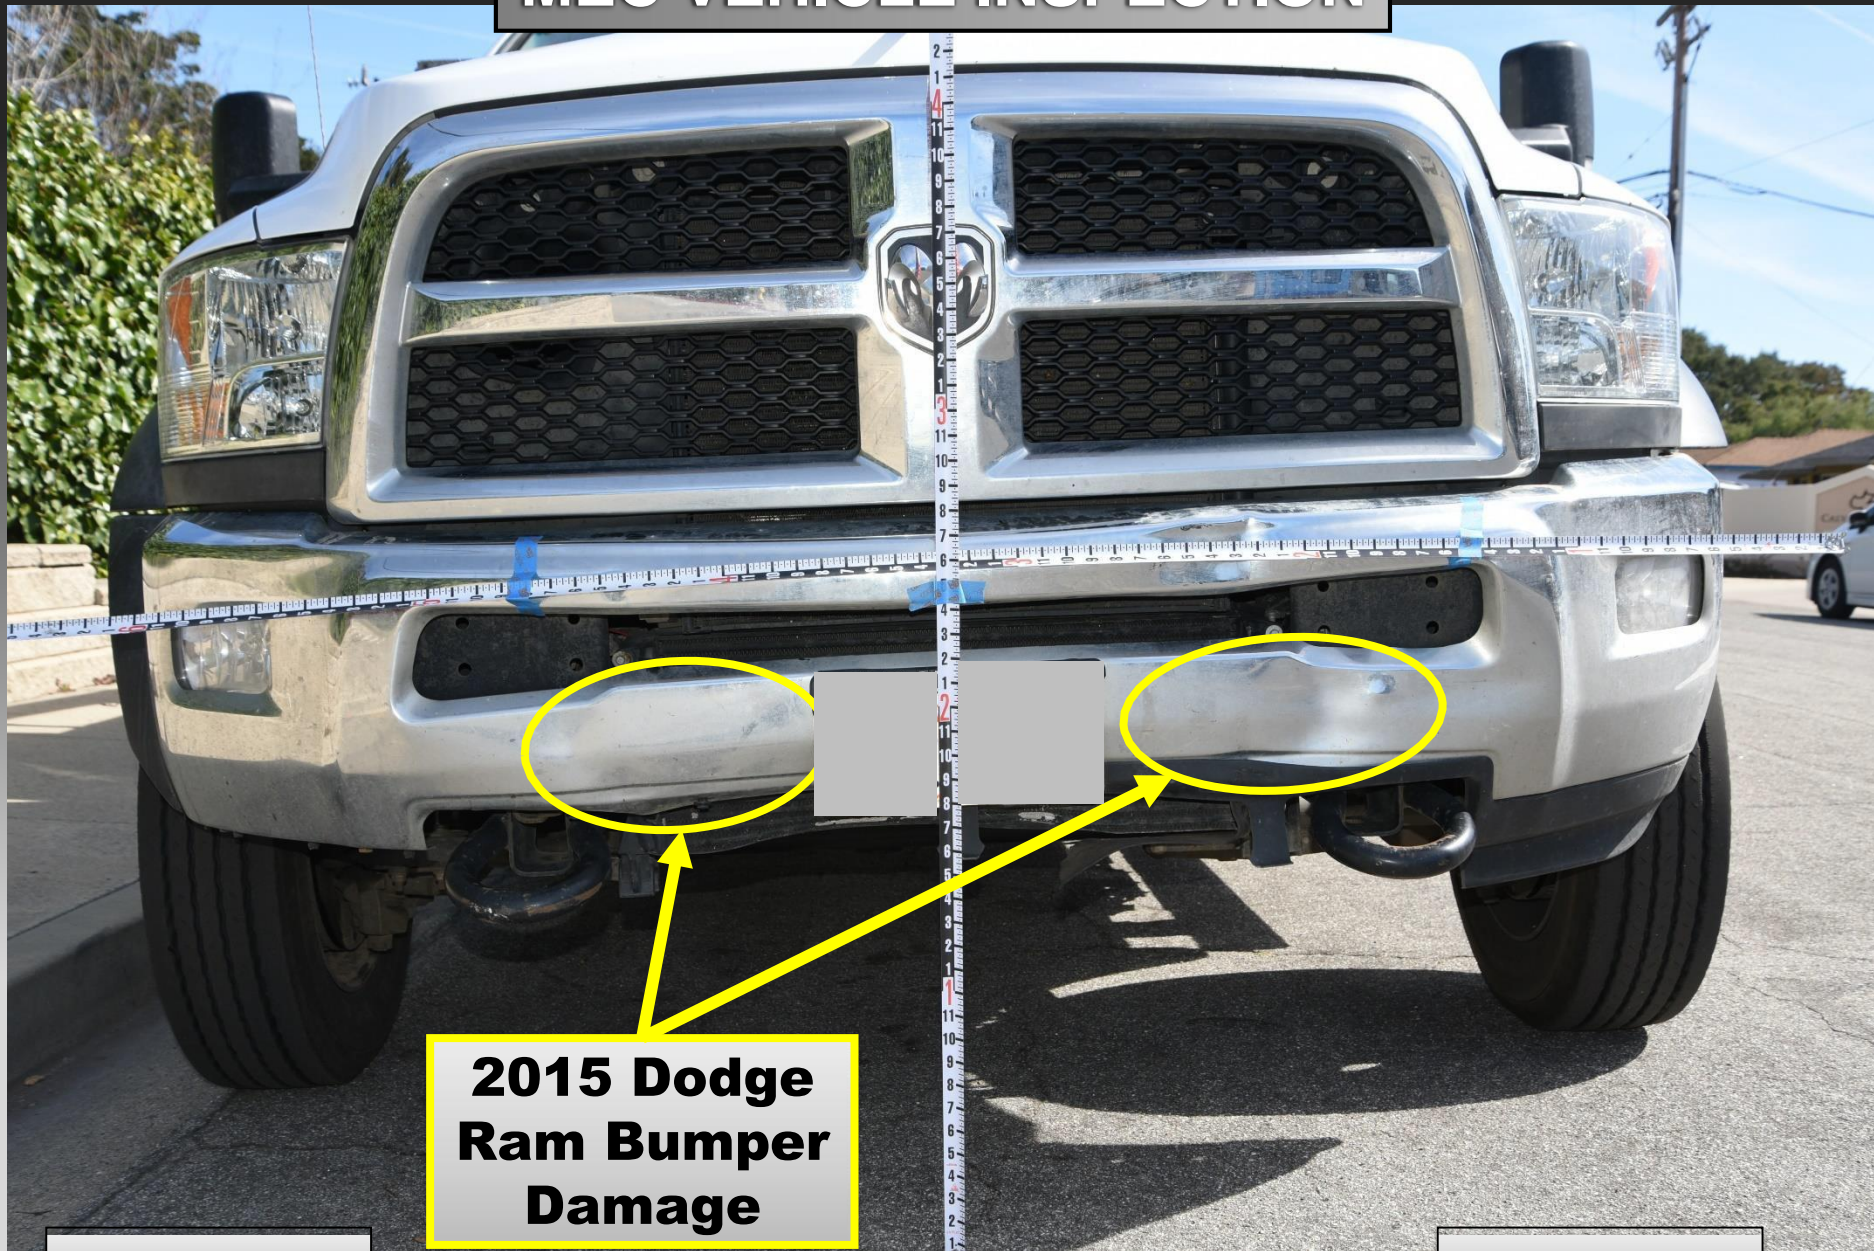
**2015 Dodge
Ram Bumper
Damage**
