MEC SITE INSPECTION

Genova v. Johnson

D.O.I. - 08/22/2017

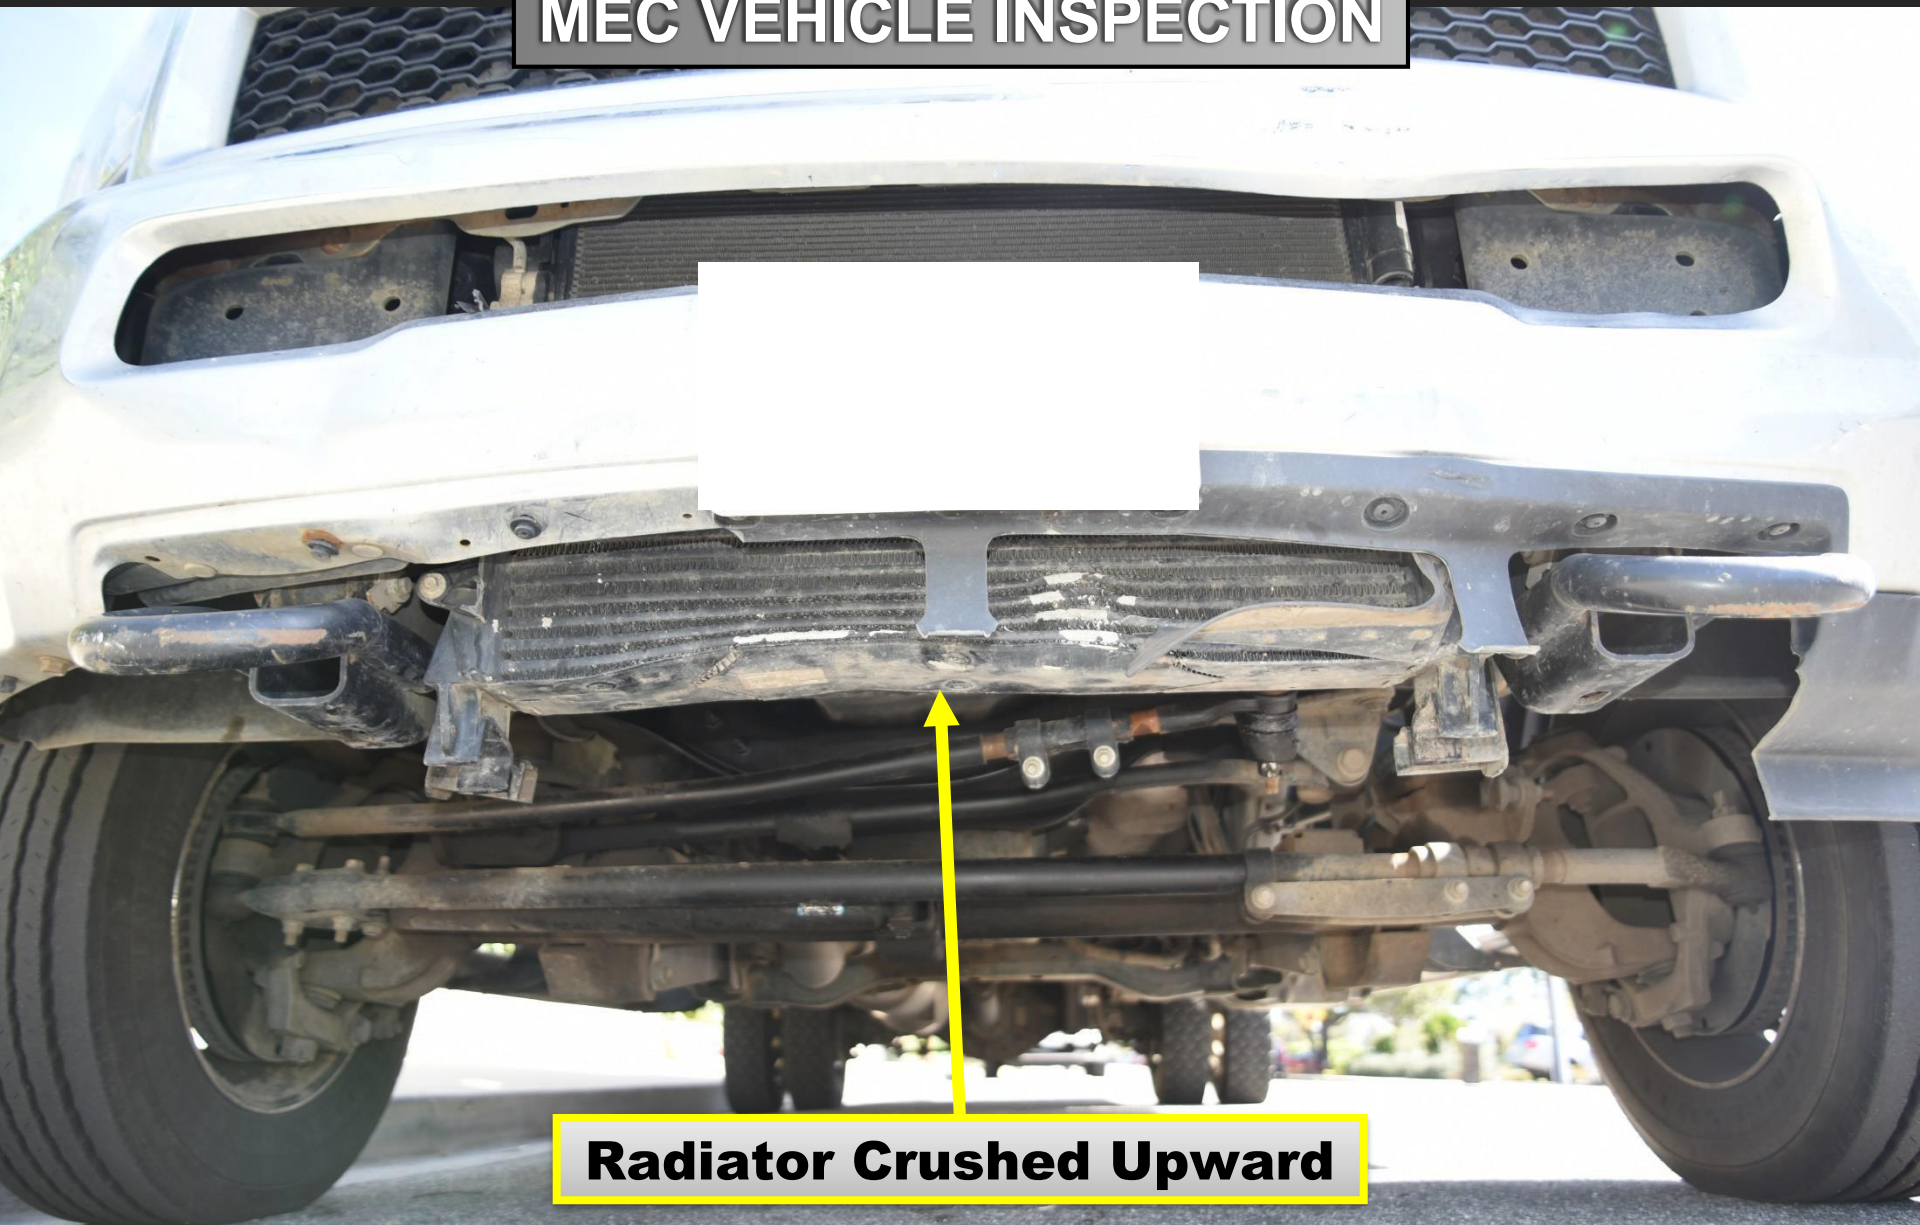
Radiator Crushed Upward

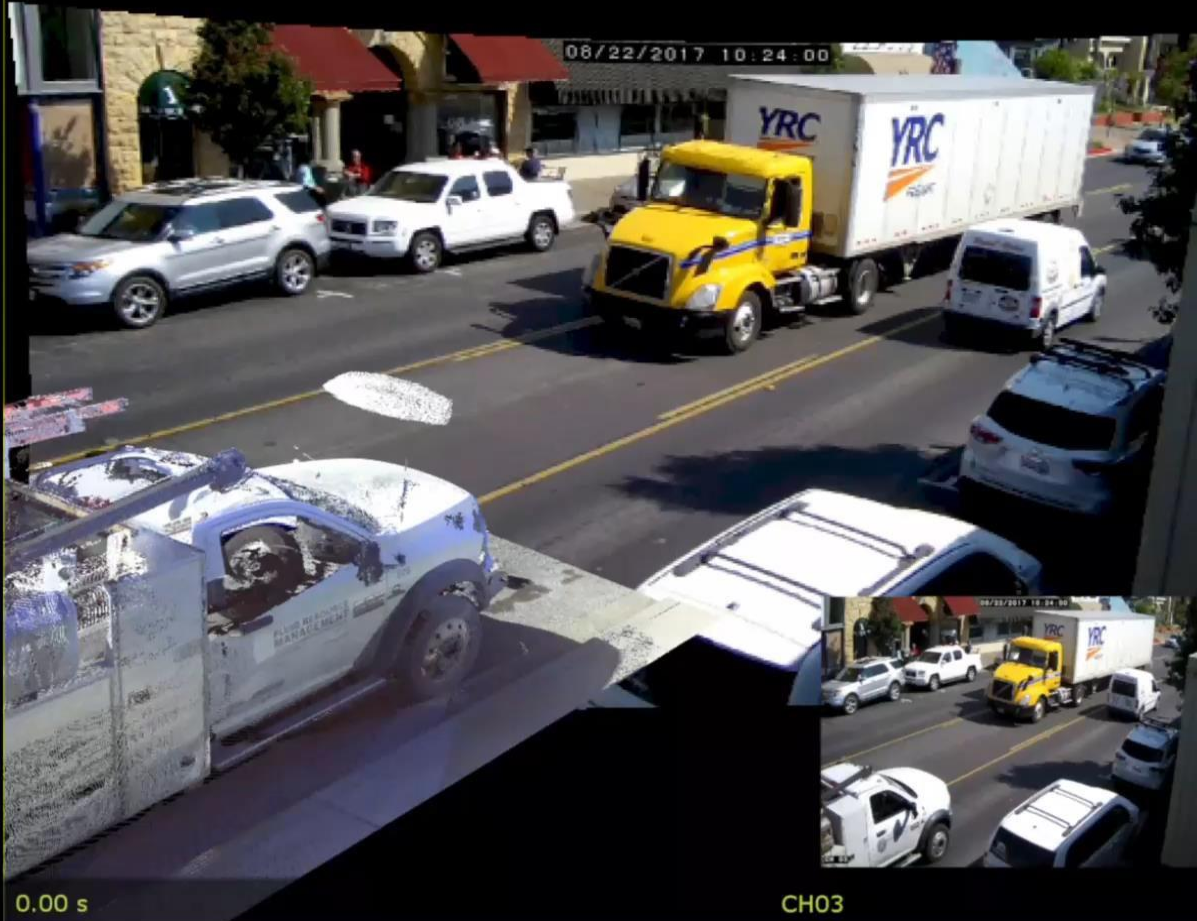
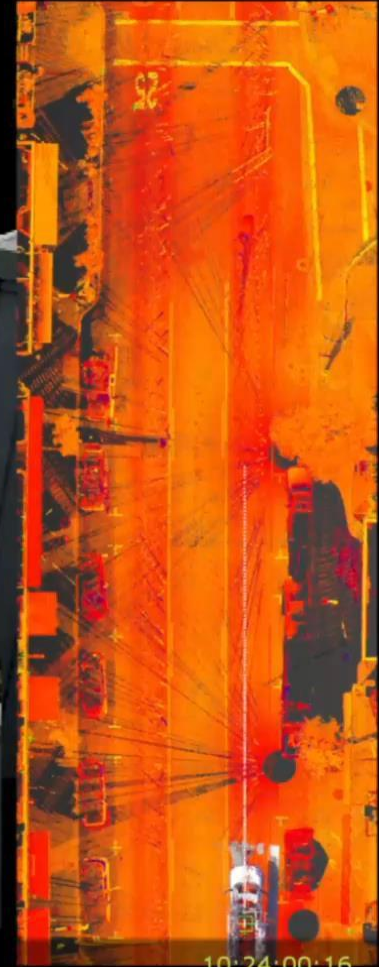
Video Analysis - Dodge Ram Speed

SPD: 9.5 Mile/h

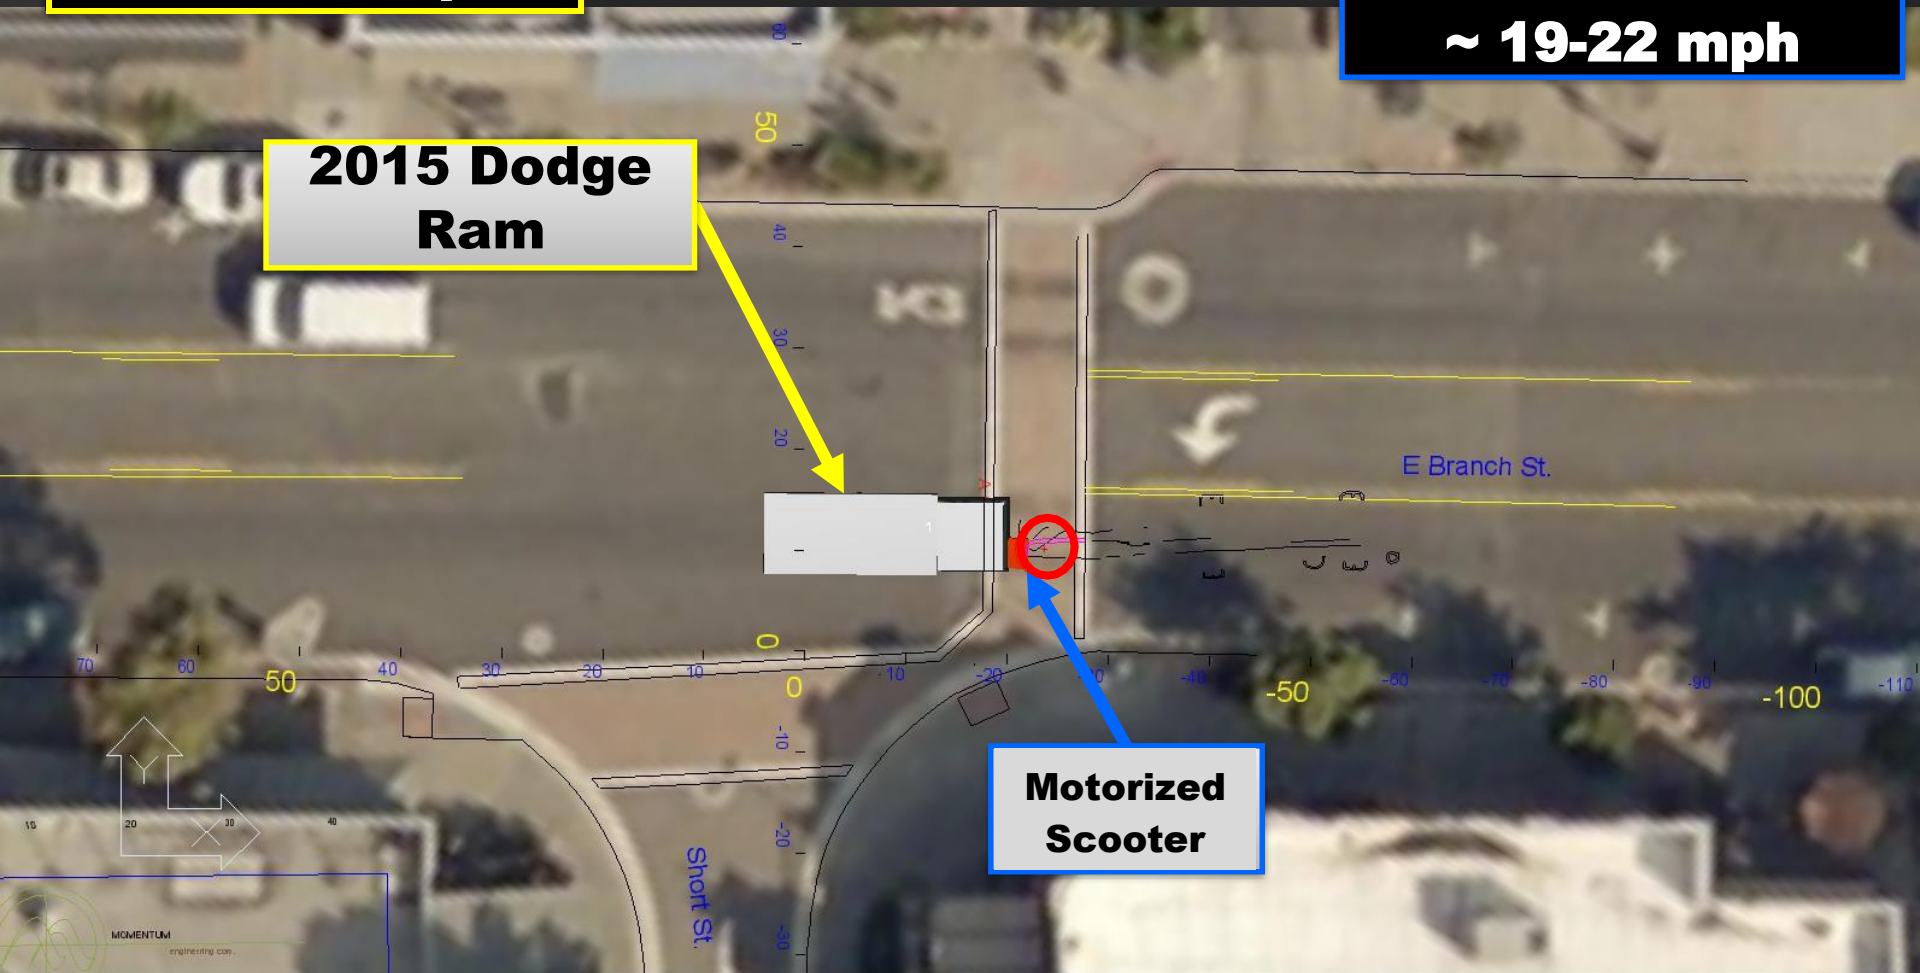
$\Delta V \sim 1-2$ mph

Impact

**Cumulative ΔV
 $\sim 19-22$ mph**

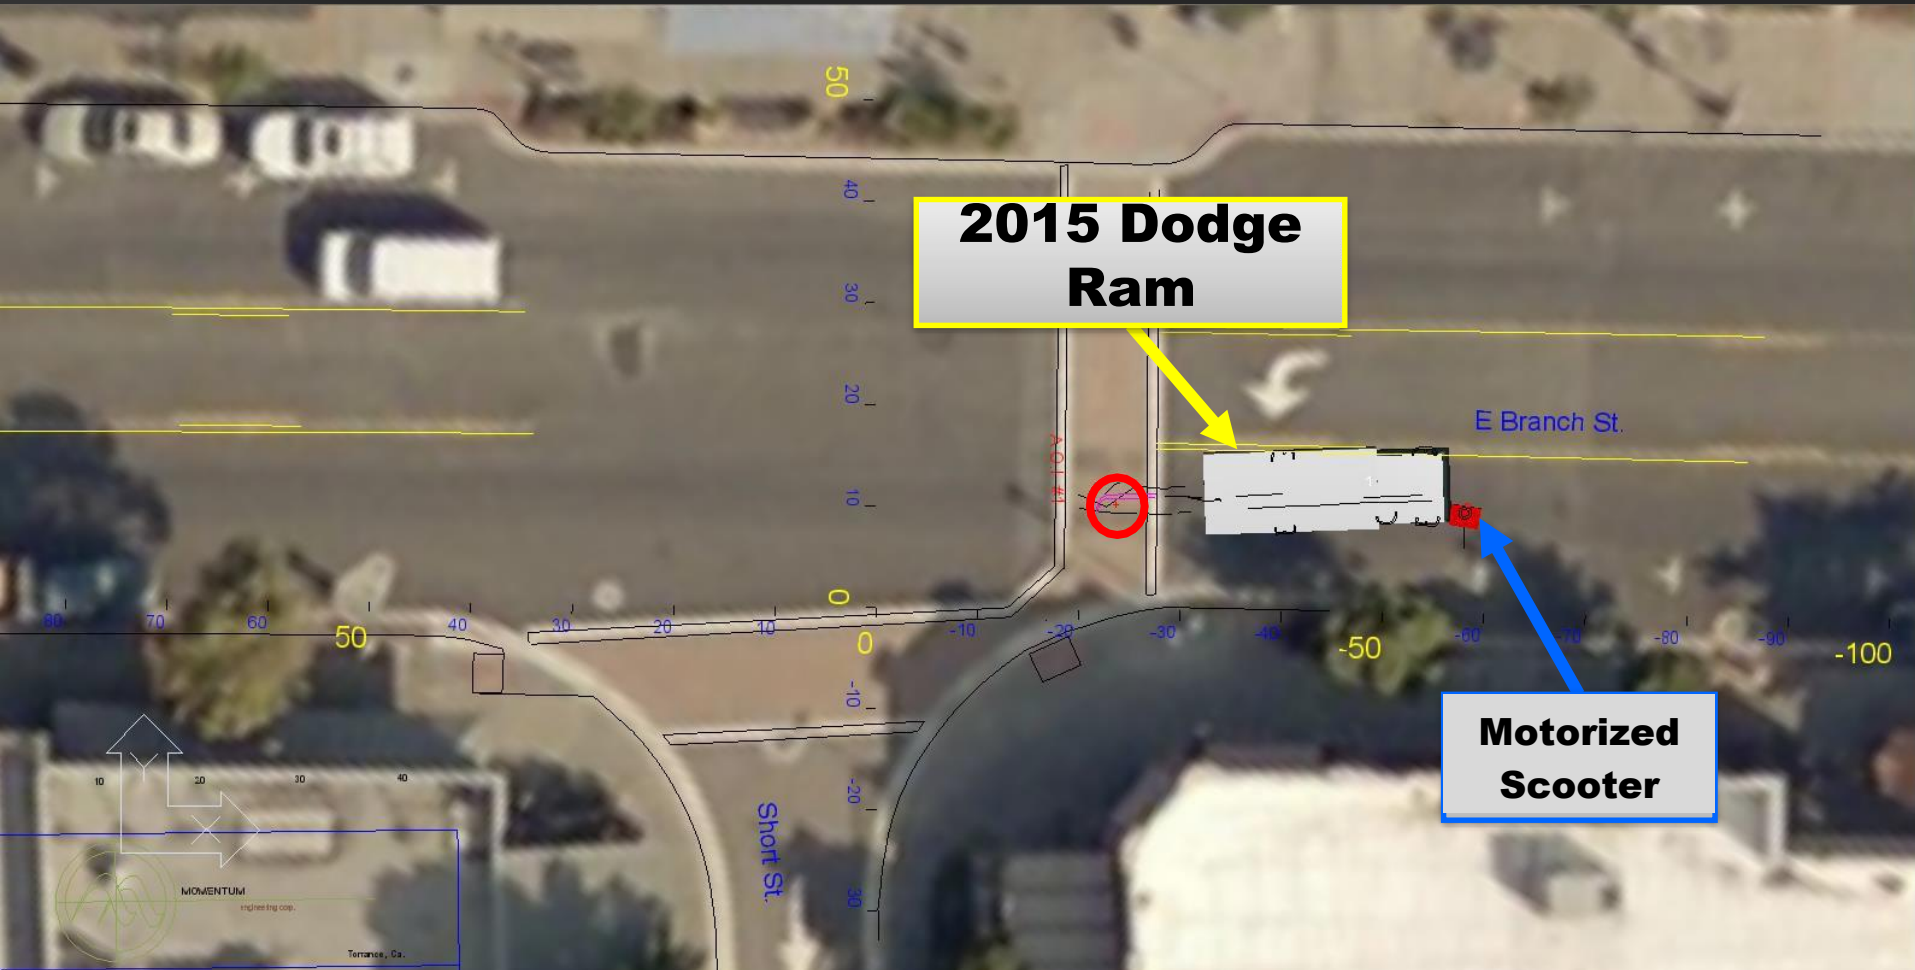
End Simulation
